UWP 3.0 Tool Download

Tips & Tricks

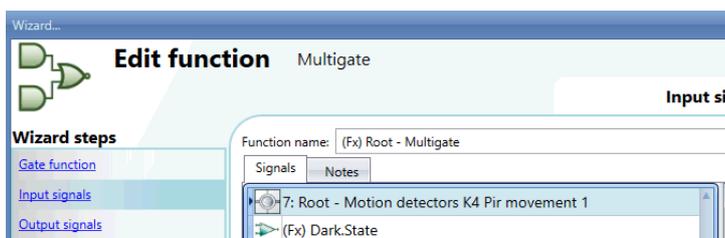
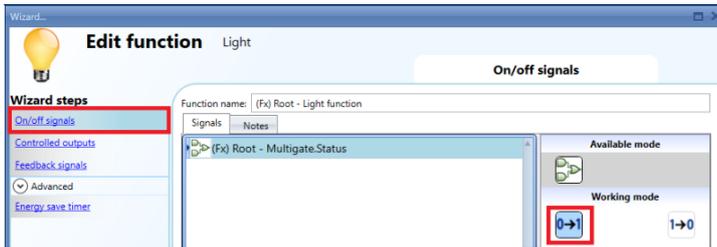
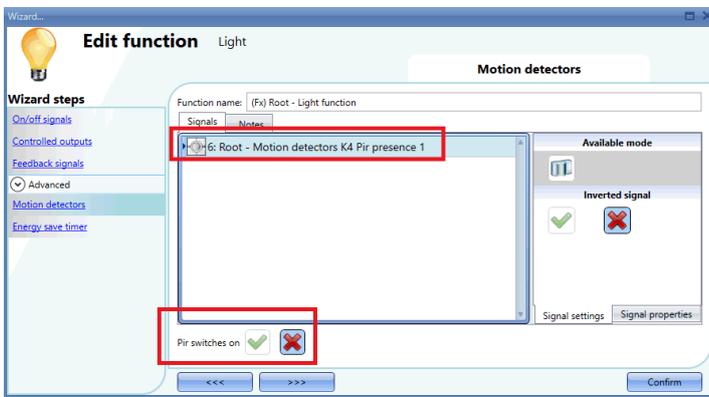
The automation of the light function puts together lux meter, PIR and energy save timer.

When the lux value is below the threshold and the PIR detects movement, the light goes on.

At this point the lux value goes above the threshold and the energy save timer is not reloaded anymore, therefore the light goes off even if there is presence in the room.

Create an external analogue comparator that is used to define the "dark" condition. Use the comparator function as input of a multigate "AND" function combined with the *movement signal* of the PIR sensor.

Use the multigate as input signal (*On/Off Signals* tab) of the Light function.

In the light function, add the presence signal of the PIR.

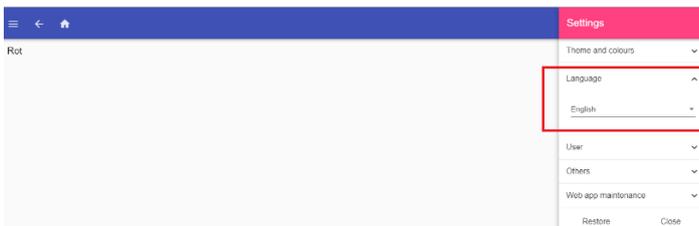
In the web app *Reports* window, you have created a template for a report in October 2018 but when you save and create the report, November 2018 data logs are shown.

You may face this issue if you run a Web browser with Norwegian or Chinese language.

The problem is due to the wrong default language that is automatically set by the Web App.

To fix this issue, navigate the web App settings, select the English language, then select again the correct language and save to apply the settings.

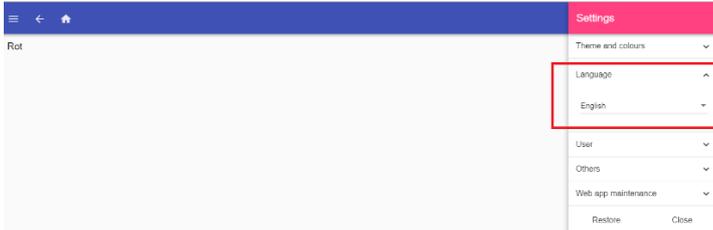
When you try to edit a calendar activity from the Web App, you get an error and the login page is shown.

You may face this issue if you run a Web browser with Norwegian or Chinese language.

The problem is due to the wrong default language that is automatically set by the Web App.

To fix this issue, navigate the web App settings, select the English language, then select again the correct language and save to apply the settings.

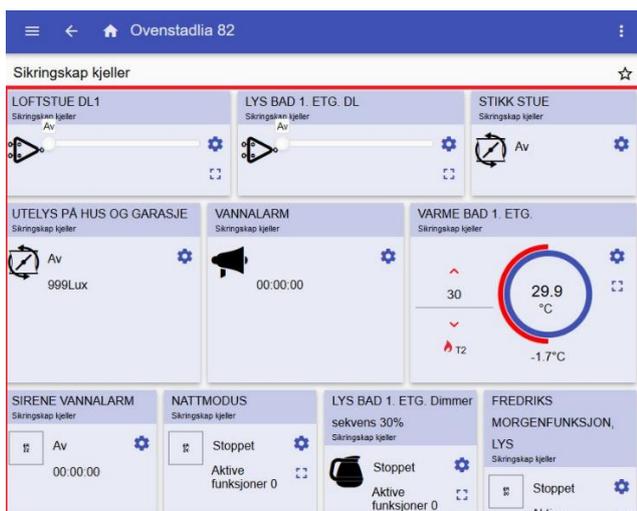
After a firmware upgrade of the system the icons in the web App are not correct (the icons are messed up or missing).

The error is due to the cache of the web browser, the issue will be resolved cleaning the cache and logging-in again in the web App.

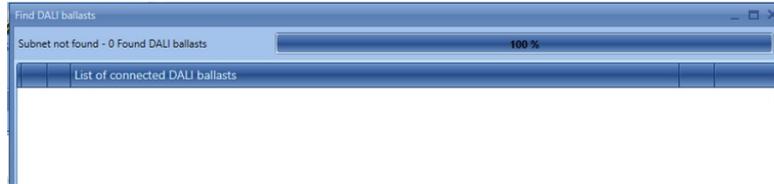
After adding the DALI module to the project, from the DALI module discovery window, the user tries to find the ballast connected, but when the search button is pressed, the discovery ends immediately with an error “Subnet not found”

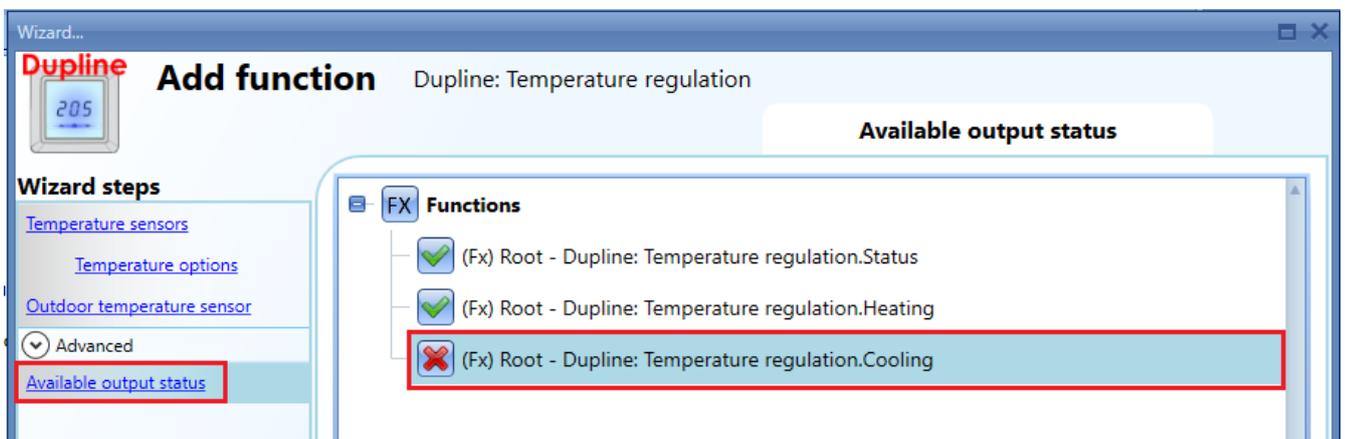
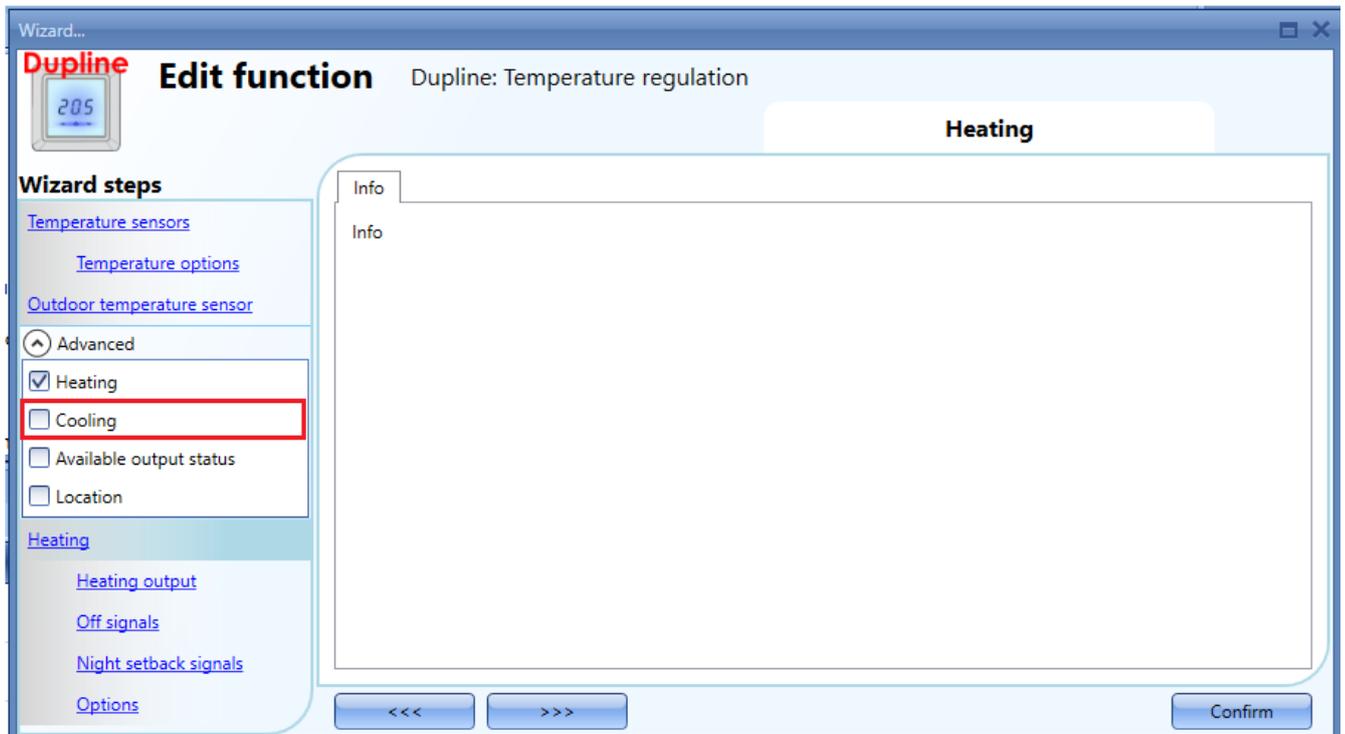
When the advanced field Cooling is selected in the Dupline temperature regulation and there is no output signal used, the temperature function activates the cooling set point every time the configuration file is sent to the controller, consequently the heating function goes from heating T1 to TOFF and stops heating. This problem happens also when the controller restarts because the system loads the configuration at start-up and the cooling setpoint is activated.

In the advanced menu "available output status" the signal *temperature regulation.Cooling* should be deactivated.

The advanced menu "Cooling" should be unselected.

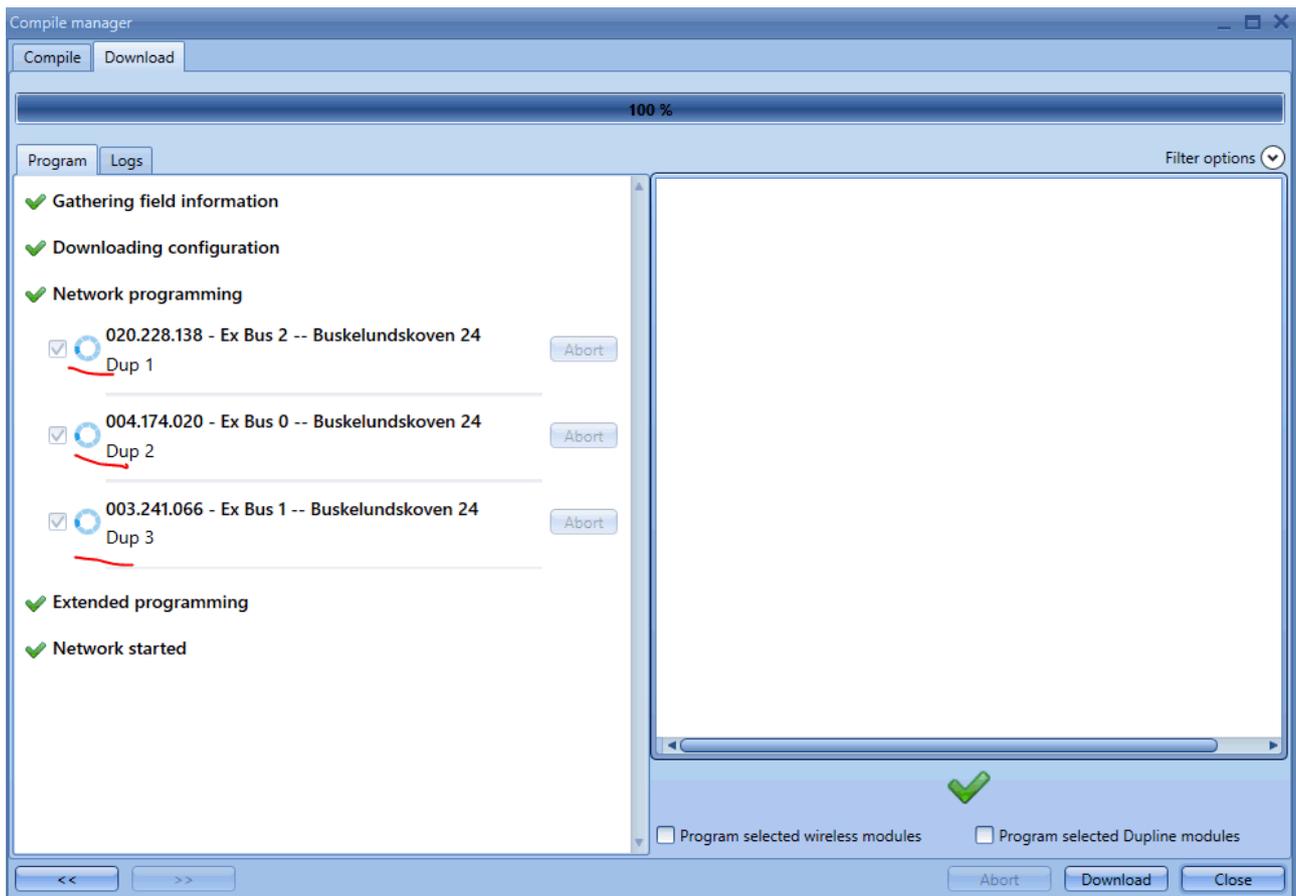
Configuration upload failing after a modification of the stress light functionality in the intruder alarm function and the system does not work as expected (no error is shown when the software compiles the configuration). This problem occurs every time a light function is added as “stress light” signal in two or more intruder alarm functions.

It is mandatory to use each light function in one single *stress light* functionality

Note: It is not possible to add the same function in two or more different stress light fields.

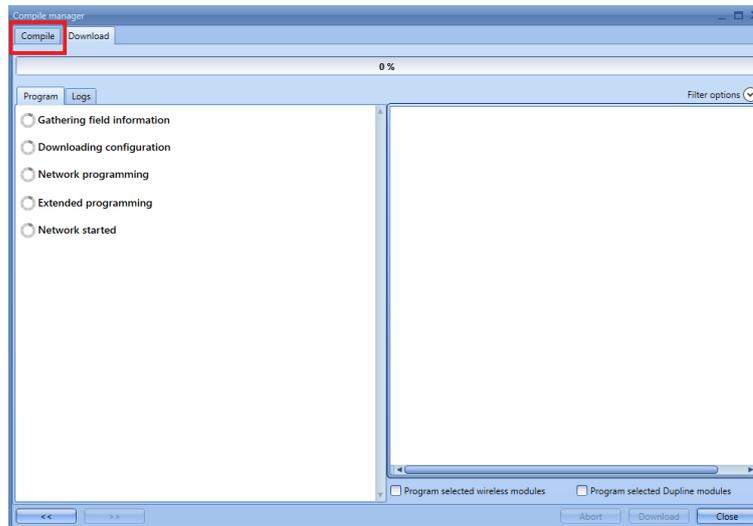
The *Download* button is not selectable after clicking on the *Send to controller* button from the *Configuration* menu.

This problem occurs every time a pre-compiled configuration is loaded in the UWP 3.0 Tool and the user clicks on the *Send to controller* button without compiling the configuration file.

1. Do not close the *Compile manager* window and go back to the previous *Compile* window

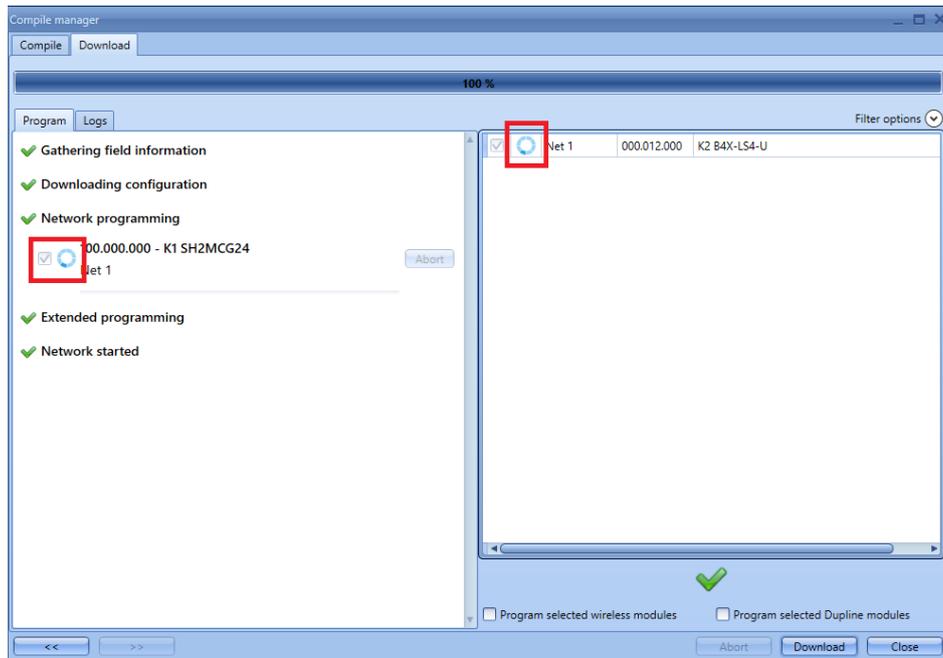
The *Download* of the configuration leads to an issue in the *Download manager* window: the icons next to the modules keep spinning even if the progress bar shows 100%.

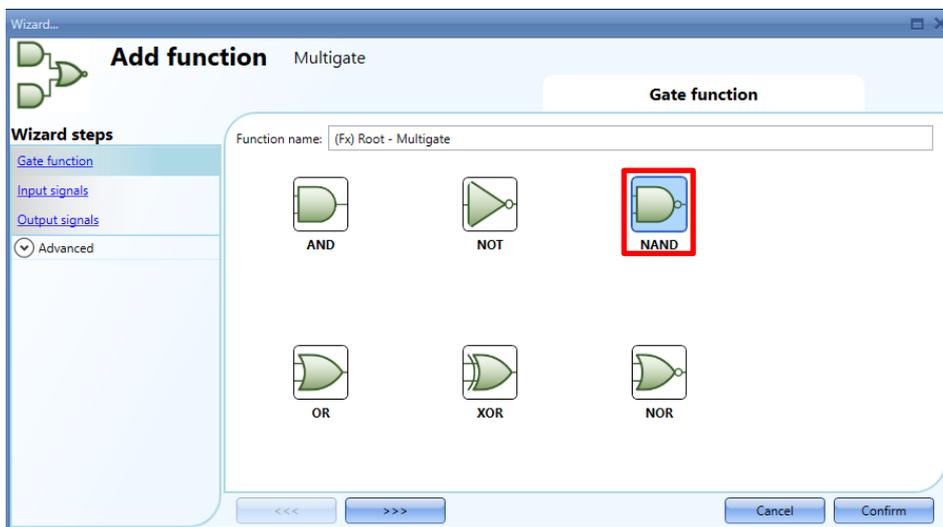
This problem occurs every time a project contains a *Multigate* function that is configured as NAND operator without input signals (the *Input signals* window is empty).

Delete all the *Multigate* functions without input signals from the project.
