UWP 3.0 Tool Download

Tips & Tricks

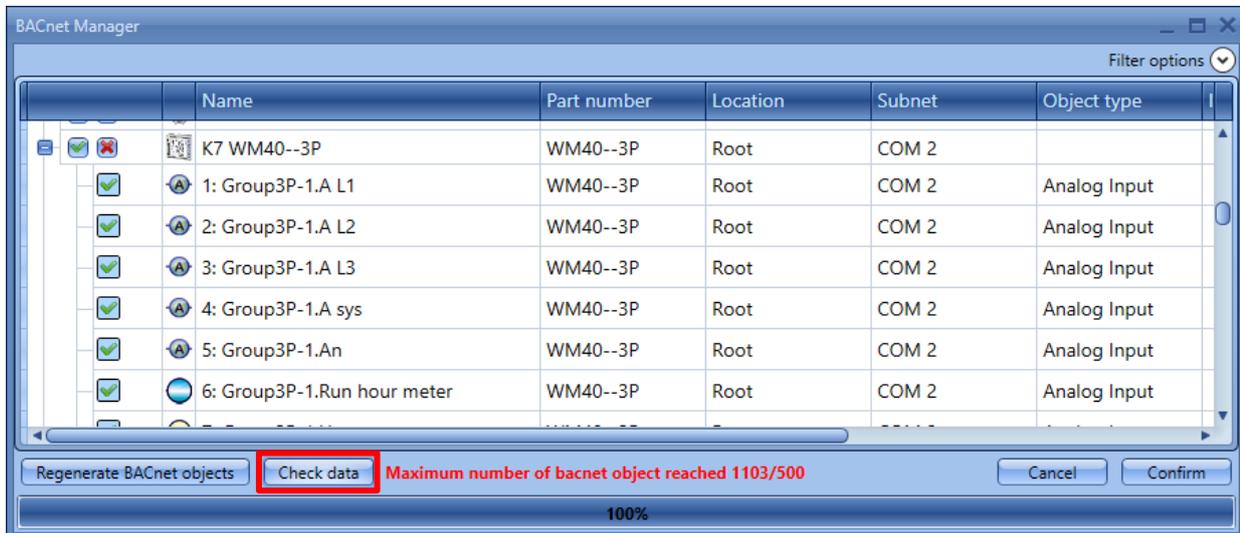
Important: Starting from the version 8.2.9.3, up to 500 BACnet Objects can be managed in a project.

As shown in the example above, a warning message will be displayed if the maximum number of BACnet Objects has been exceeded and their amount; otherwise the **Ok** message will be displayed when it is compliant.

Note: It is mandatory to delete the excess BACnet Objects and compile the configuration before sending the project to the UWP 3.0 controller.

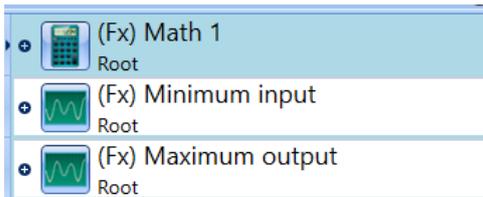
In the Database window, the additional function status of a function is not available and it is not possible to log them into the Database of the system.

- a. Add to the project one Analog Output function for each additional status not available in the Database.

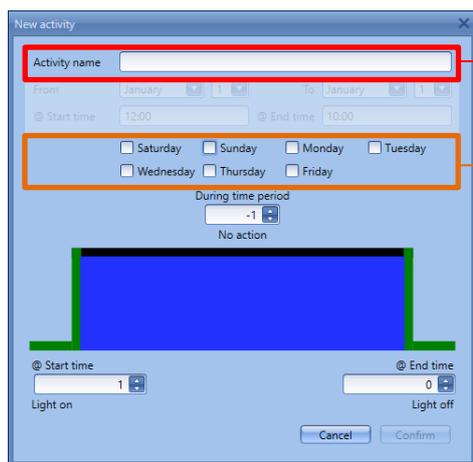
This happens if at least one of the following conditions is verified:

The *Activity name* field has to be entered

At least one week day has to be selected
